Prevention of Turtle's Access to the Road: Specifics of the Environmental Impact Assessment Conditions and Measures Issued for the Priority Objects from the National Linear Infrastructure Network in Bulgaria

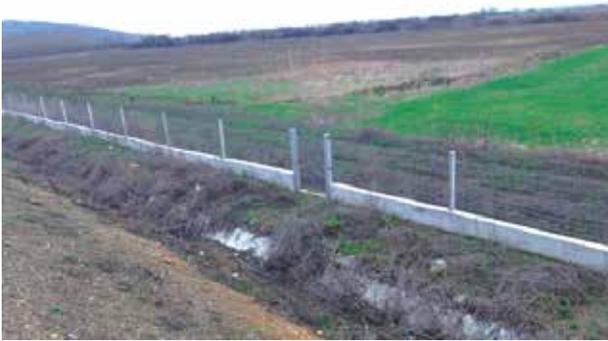
Fig. 1. Concrete walls for protection of vehicular turtle mortality at Trakiya Motorway. Note the gap in the wall where the service door is mounted

Other older documents also prescribe the construction of extended concrete walls to stop turtles (EIA DECISION № 14-2 2009, AA DECISION № 104 2009, EIA DECISION № 5-3 2010). Actually, according to our experience, building of concrete walls has proven impractical and has a lot of disadvantages. In fact, the concrete walls suffer severe construction flaws. The long walls have to be periodically disrupted by "expansion joints". These joints are necessary, because concrete is not thermally stable and shrinks and swells depending on the climatic conditions. Another downside of the concrete walls is shown on Fig. 1 and 2. These figures represent the only ever build concrete walls for turtle protection in Bulgaria. The obligate "rabbit nets" along motorways should be equipped with both small and large hinged doors for access by maintenance vehicles (LoR 2012). Since such equipment cannot cross the concrete walls, the walls are interrupted in uneven sections. We assess the efficiency of such constructions in preventing turtles to appear on the asphalt as very low. We also have to stress that

concrete walls may be dangerous in cases of vehicular accidents on the road.

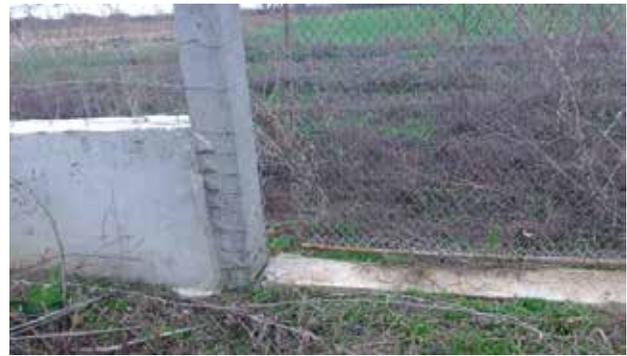
Fig. 2. Close-up of the service door built in the concrete walls for protection from vehicular turtle mortality at Trakiya Motorway

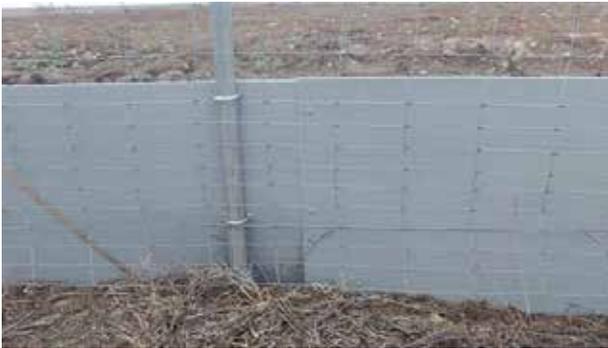
Fig. 3. Glass Fiber Reinforced Polymer (GFRP) plates used as barrier for preventing vehicular turtle mortality at the "Trakiya" motorway. Note the stable mounting of the plates to each other and to the metal pole

Because of the drawbacks of concrete as a building material for protection walls, other designs were used during the building of later linear infrastructure objects. On particular sections of Lot 4 of Trakiya Motorway, flat and stiff barriers made of Glass Fiber Reinforced Polymer (GFRP) plates were constructed. The base of the plates was buried 15 cm in the substrate; the plates were connected to each other via metal pins and additionally stabilized by a pole (Fig. 3). The plates were fixed at the bottom of the rabbit fences and represent effective barrier for turtles. This construction is much more appropriate than the concrete walls. The mounting system allows for rapid and uncomplicated repair and exchange of damaged elements. Another important advantage of the plates is that they can also be mounted at the doors for the service vehicles. Despite being more appropriate than the concrete walls, the plate barriers also have some negative aspects. Plastic screens of this kind are vulnerable to mechanical damages (HUIJSER et al. 2008a). The plates also aid in the collection of water at their base (as they are usually lower than the road level and their foundations can be flooded by intensive rainfalls). This may result in destabilization of the rabbit fences and even of other elements of the construction bed including the road itself.

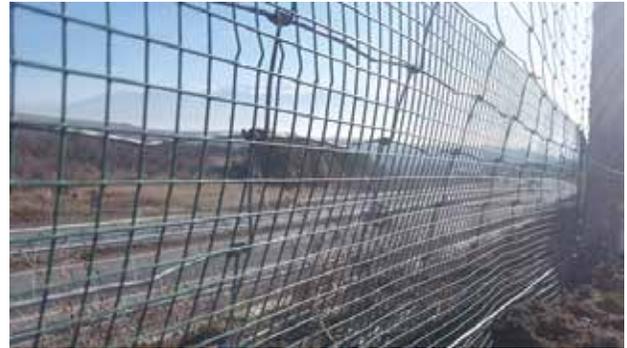
Fig. 4. Close-up of the fences constructed at Lot 1 of the Struma Motorway. The fine net is buried deep in the substrate and firmly fixed at the basis of the standard rabbit fence

Fencing by using nets has proven a suitable tool for reducing road mortality in turtles (for overview see ARESKO 2005, HUIJSER et al. 2008a,b). For Struma Motorway, a combined team of experts (including environmental specialists, engineers and designers) introduced to MoEW different designs for protection of turtles based on the use of nets. The approved design was implemented for the first time on Lot 1 of Struma Motorway. As a base, polymer coated sturdy metal nets with a mesh of 10 mm were used. The builders obtained net rolls with a width of 1 m. The rolls were half split in long sections of nets with a height of 50 cm. The net was buried 15 cm in the substrate and the remaining 35 cm were fixed to the standard rabbit nets and slightly tilted outwards from the road (Fig. 4). The design is rather similar to the devices build for protection of turtles (e.g. Gopher Tortoises *Gopherus* sp. and Alabama Red-Bellied Turtle *Pseudemys alabamensis*) in USA (HUIJSER et al. 2008a). This construction possesses several important advantages over the wooden, concrete and plastic alternatives. First, it is very strong and durable. It cannot be damaged by the turtles and other small animals, whilst it is flexible and can be adapted to the irregularities of the terrain. The net is protected from rust by a plastic coating and has a twelve-year warranty from the producer. The most

important advantage of the net is that it does not collect rain water and there is no need of drainage system.
